Service Technical Information

MODEL NO. XR-MD90 EZ
SUBJECT Noise at tuner function

REF.No. :G - 99 - 055 - E0

DATE :08. NOV . 1999

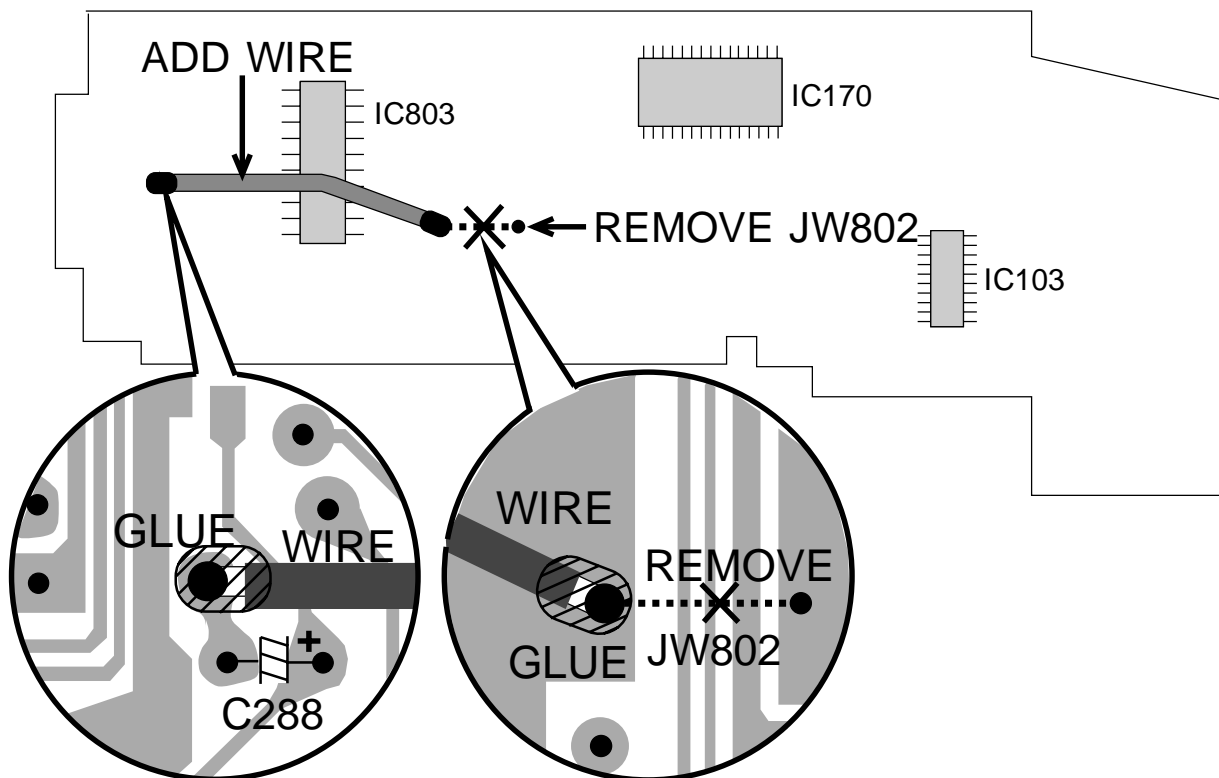
TUNER C.B PATTERN SIDE

A high-frequency noise is heard with a volume at "0" position in the tuner function mode.
Take the following actions if the problem occurs.

1. Remove CABI, TOP AMP in the amplifier block.
2. Remove the JW802 tuner C.B..
3. Solder the wire onto a JW802 pin (one connected to pin 5 of IC803).
4. Solder the other side wire onto a digital ground (minus pin of C288).
5. Lock the both end of the wire with glue.
