Service Technical Information

AM-HX50 / HX55

Noise heard on headphones during playback operation

REF.No. :G - A0 - 042 - E0

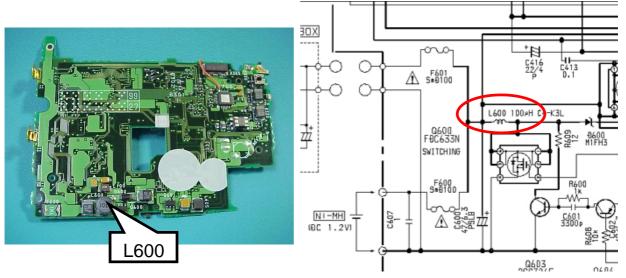
Circuit diagram for power supply section

The models concerned may produce low-level noises with volume at minimum position. The noises occur in synchronization with blinks of OPE LED, approximately 8 seconds after starting playback operation.

Main unit OPE LED

Change the values from 100 μH to 180 μH on L600 in the power supply section.
